**RESPONSE TO CITY OF ROCHESTER
VIOLATION NOTICE (JUNE 6, 2023)**

ROCHESTER TOWERS

ROCHESTER, MINNESOTA

June 29, 2023

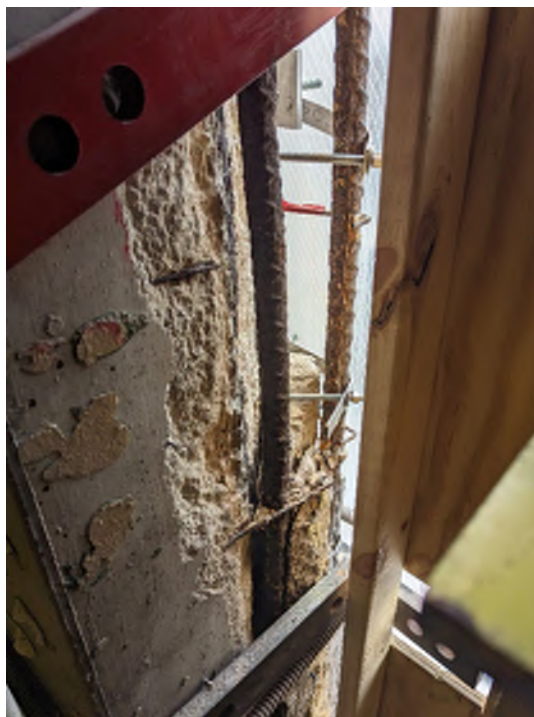
Floor 2 – Grid B/8:

This column was observed to have the most severe damage where concrete was observed to have been removed from within the rebar cage (Figure 1).

Figure 1: Damaged concrete within column rebar cage.

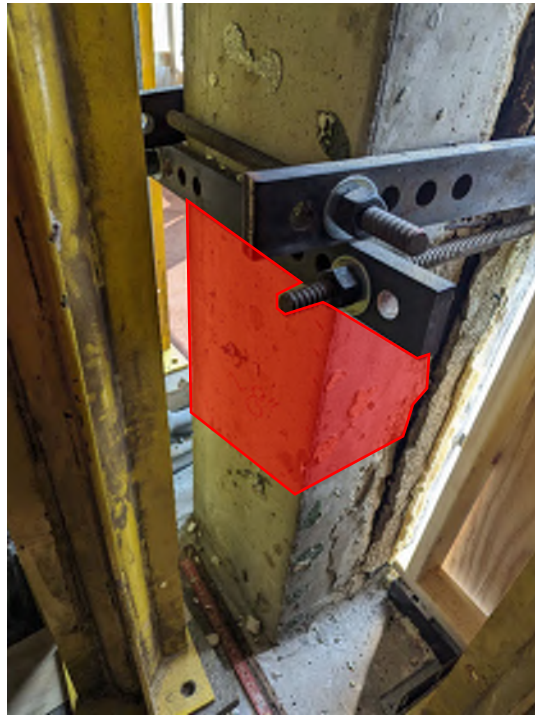
AET observed an isolated area approximately 1-1/2' to 3' up from the column base where an anomaly was observed approximately 8" inward at the center of the column (Figures 2 and 3). The remaining concrete appeared sound.

Figure 2: The red region where the internal anomaly was observed.

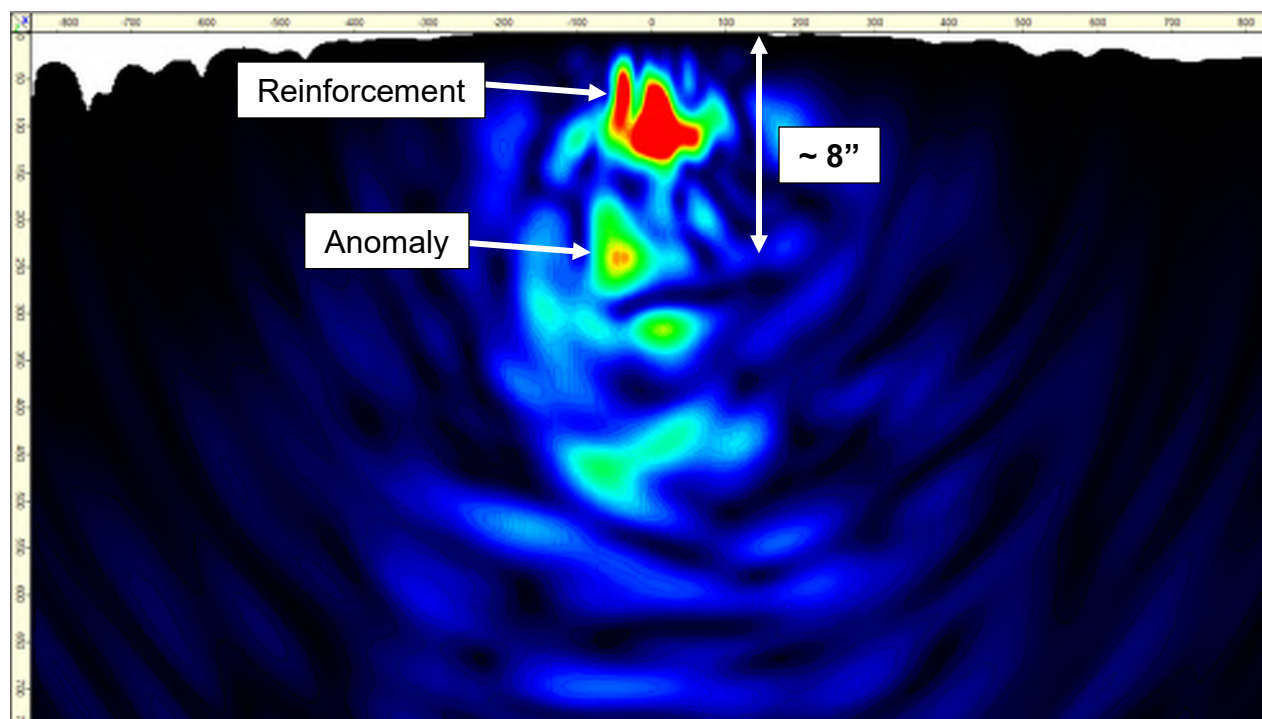
Figure 3: MIRA data of anomaly

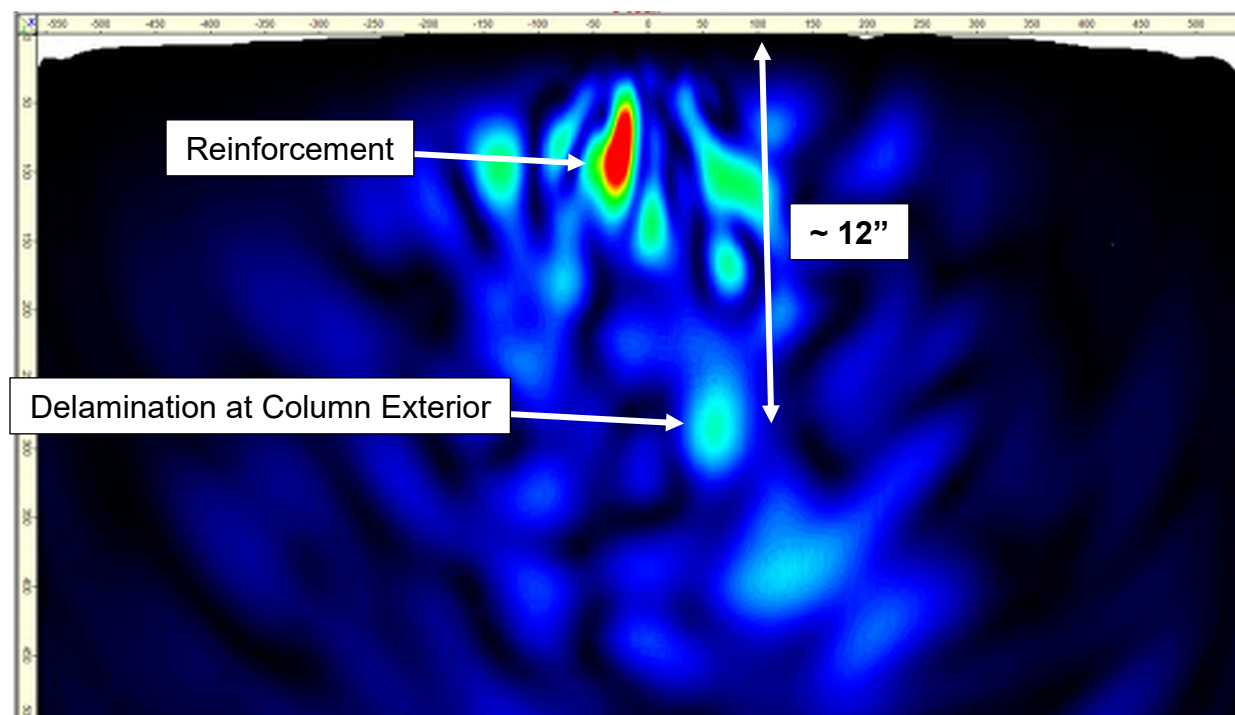
Floor 2 – Grid E/8 and E/9 Columns:

Encompass observed delaminations on the exterior faces. The MIRA equipment did not observe anomalies within the concrete column at these locations. The affected concrete appears to be limited to the region of concrete outside the rebar cage (Figure 4).

Figure 4: MIRA data from E/8 column

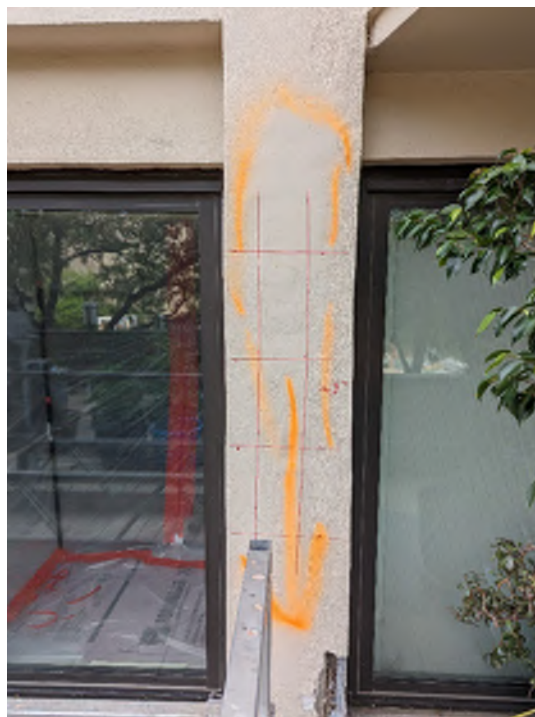
Floor 1 – Grid E/5 Column:

We collected MIRA data at the north, south and east faces of the columns at this location where delaminations were observed by Encompass. The concrete thicknesses at these locations were observed to range from 3" to 4" suggesting the delamination is outside the rebar cage within the column (Figures 5 and 6):

Figure 5: Delaminated region

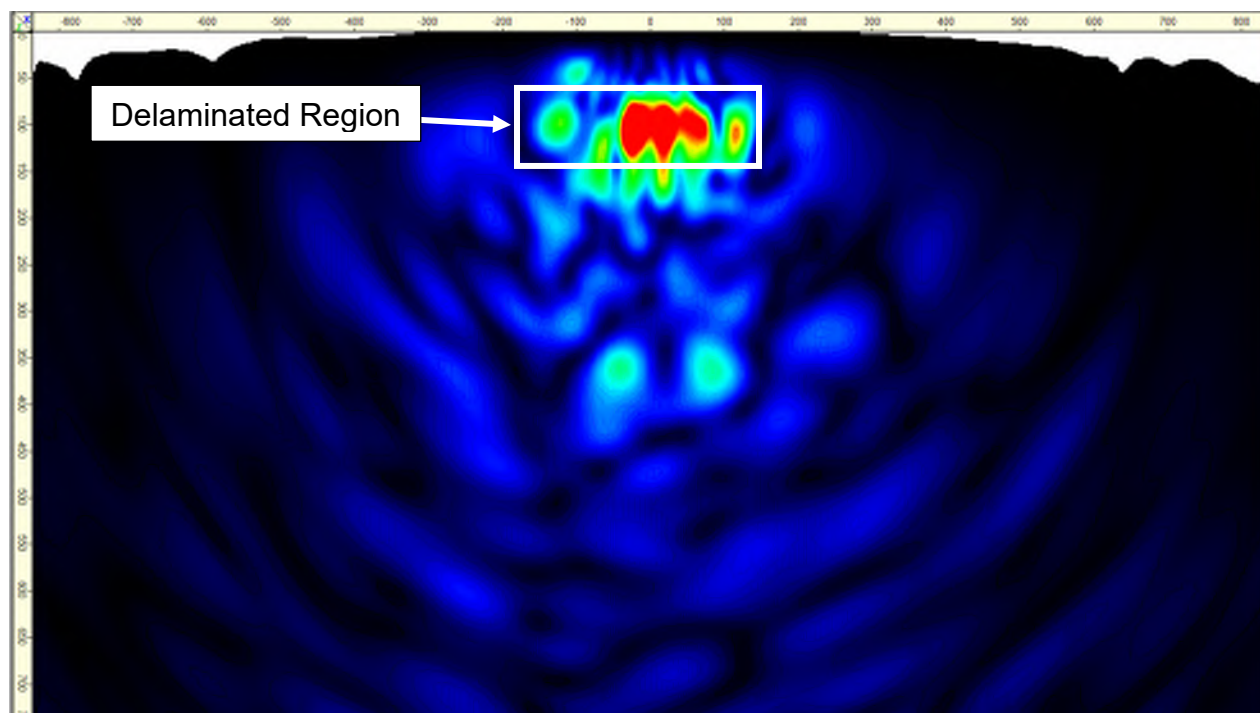
Figure 6: MIRA data from E/5 Column

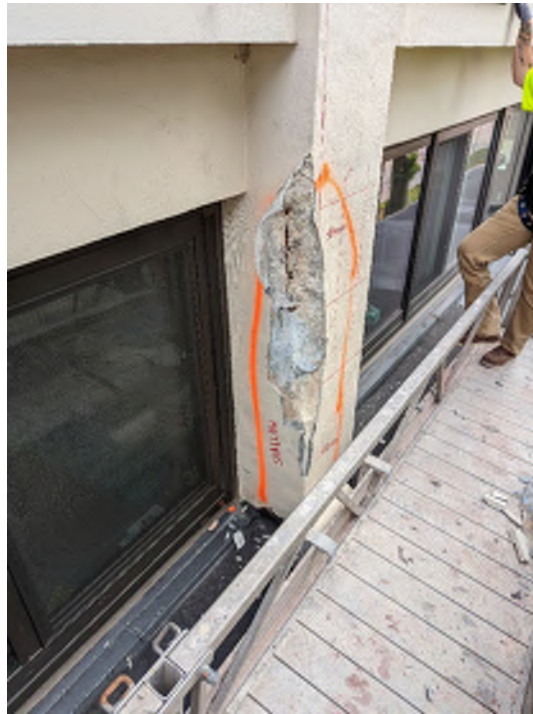
Floor 1 – Grid D/2 Column:

The delamination at this region appeared to be shallow or within 1” of the concrete surface (Figure 7). The MIRA equipment was not able to transmit a signal beyond the delamination / sound concrete interface.

Figure 7: The delaminated concrete at this location appeared to be less than 1” thick.

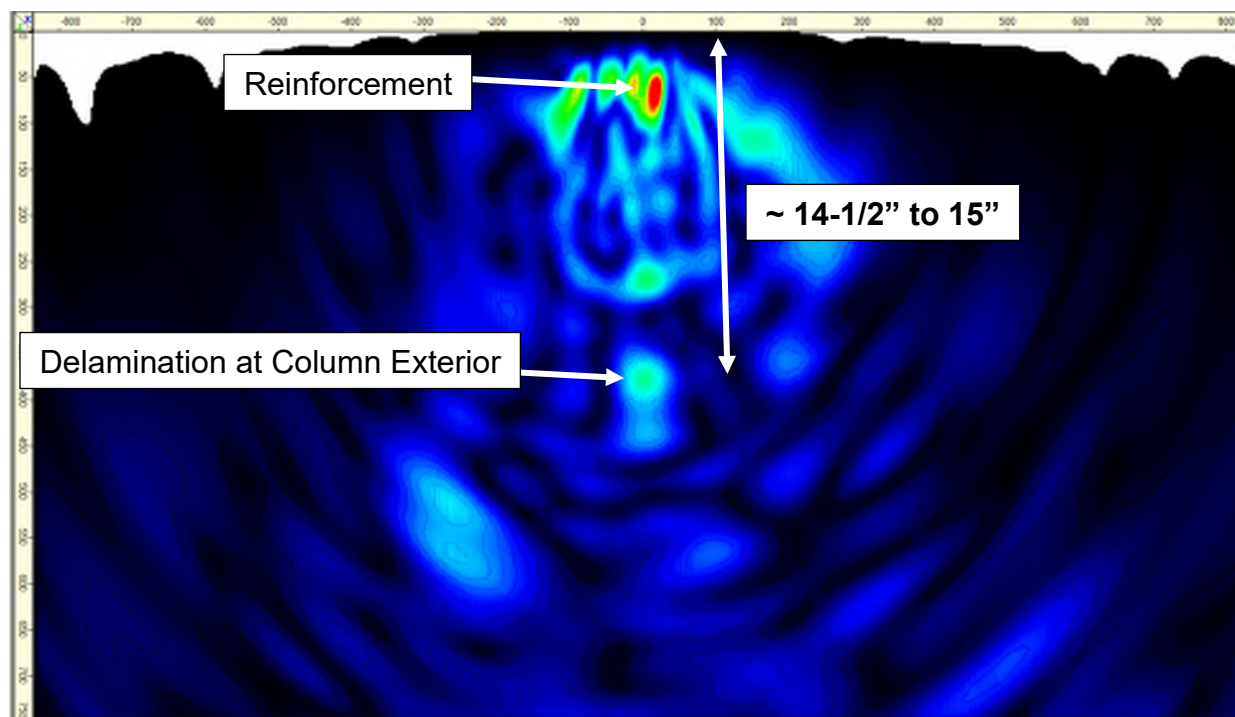
Floor 11 – Grid E/6 Column:

The delamination observed on the exterior face of the column appeared to be limited to the exterior surface (Figure 8).

Figure 8: The delamination on the exterior face of the wall appeared to be approximately 1" thick.

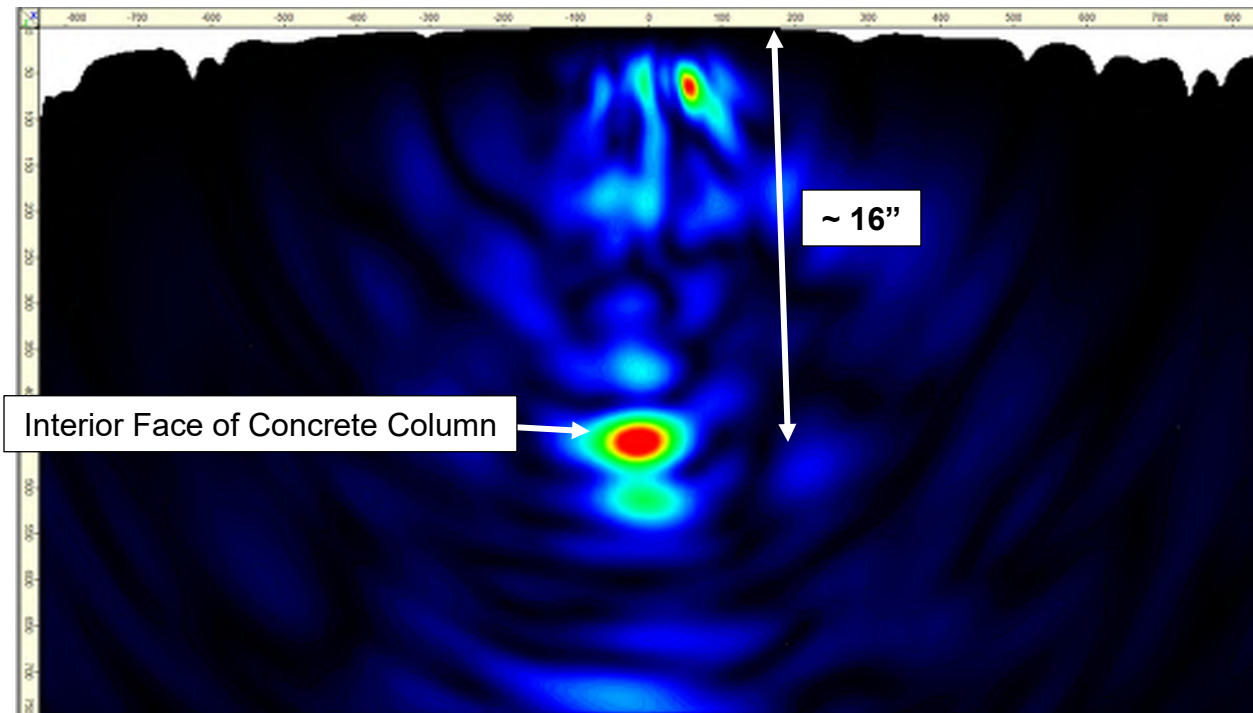
Floor 1 – Grid B and Floor M – Line 2 Spot Checks:

We collected individual MIRA scans on the exterior faces of the columns at these locations. We did not observe unsound concrete with the MIRA equipment at these locations. The backside of the concrete columns were clearly visible at each of the locations tested (Figure 9).

Figure 9: The backside of the concrete columns were visible. We did not observe anomalies within the columns at these locations.
